5. TEST RESULTS

5.2 Individual Panel Test Results

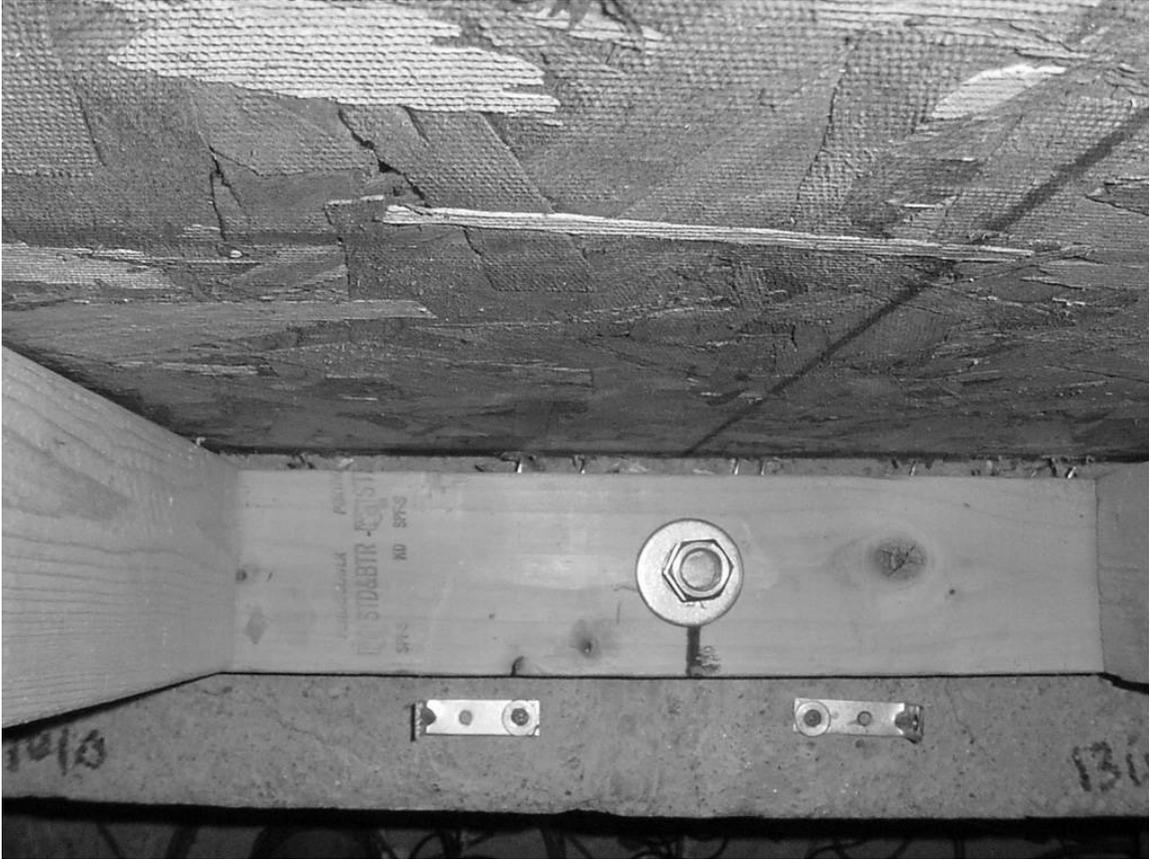
The physical connections of the two steel beams with stops on both ends held together well. Negligible play or movement was noticed in the connection. At the start of test of panel 1, the wall immediately rocked back onto the hold-downs as the end studs lifted up from the sill plate. This deflection was the result of the eccentricity between the hold-down anchor bolt and the sheathing fasteners along the end-wall. The end-wall studs rotated about their inside edge. As the displacements increased, the staples started to pull away from the framing and tear through the sheathing along the bottom edge of the panel. Viewing from the inside of the panel, I could see the sheathing begin to rotate around the center of the wall. As the cycles increased, the deflection of the top of the wall increased, and the separation of the end-wall studs from the sill plate increased and spread into the interior studs. No data were taken from this test. The failure mechanism observed was similar to those found by Shipp et al. (2001), who had also witnessed the shear walls first failing along the bottom edge of the sheathing. Figure 5.1 shows a photo

Figure 5.1. Panel 1 fastener and sheathing failure at the sill plate.

of this failure. After testing panel 1, it was decided to test three 4' wide x 8' tall panels constructed to panel 1 specifications and then try to improve the performance of the wall by controlling the uplift of the end-wall studs.

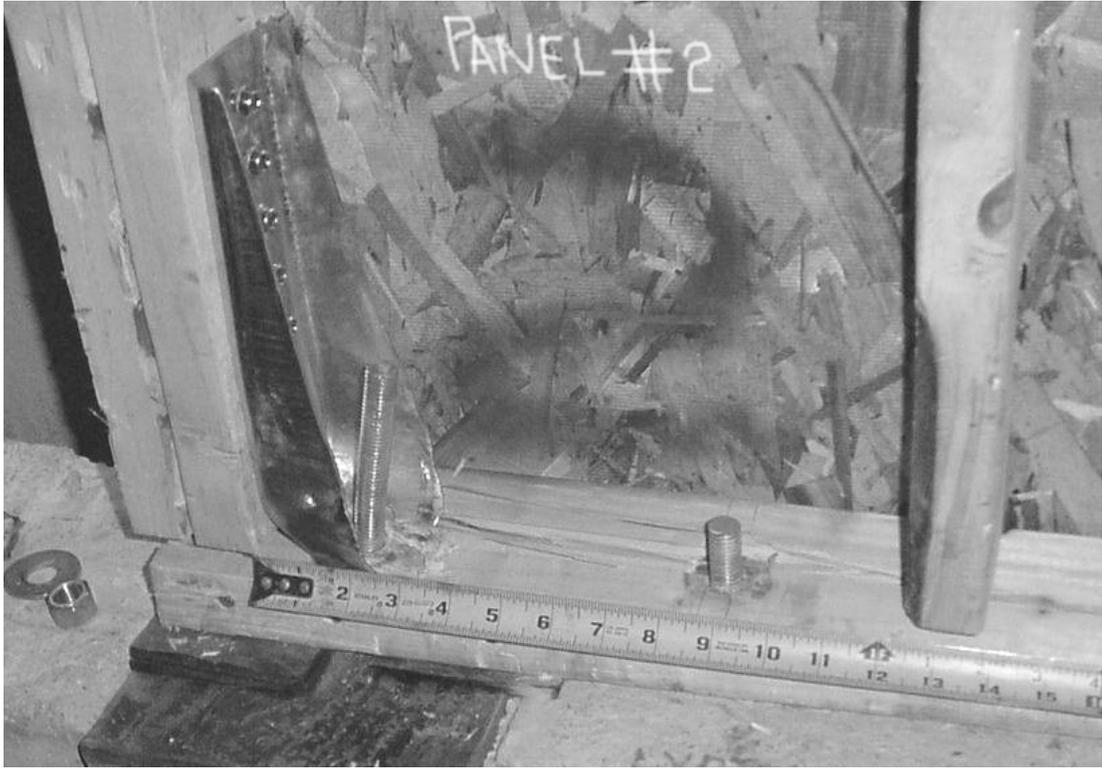
Panel 2 failure elements were: (1) the failure of the single row of staples along the bottom of the panel and (2) the sill plate splitting. The sill plate split from the cross-grain bending along the length sill, from the outside edge where the sheathing was fastened back to the interior anchor bolts (Figure 5.2). The sill plate was split from its end back to the center stud.

Figure 5.2. Panel 2 sill plate splitting along centerline.

The staple failures along the bottom edge of the panel came from the staples cutting through the OSB. The staples worked themselves out of the framing 1/4" and did not shear off in the framing. The failure mode was the sheathing crushing and disintegrating around the staple leg. From this behavior, it was determined that this size staple would perform well in thicker sheathing. Fastener fatigue was a common failure in all of the researched reviewed in Section 2 and the reason for one of the papers (He et al.

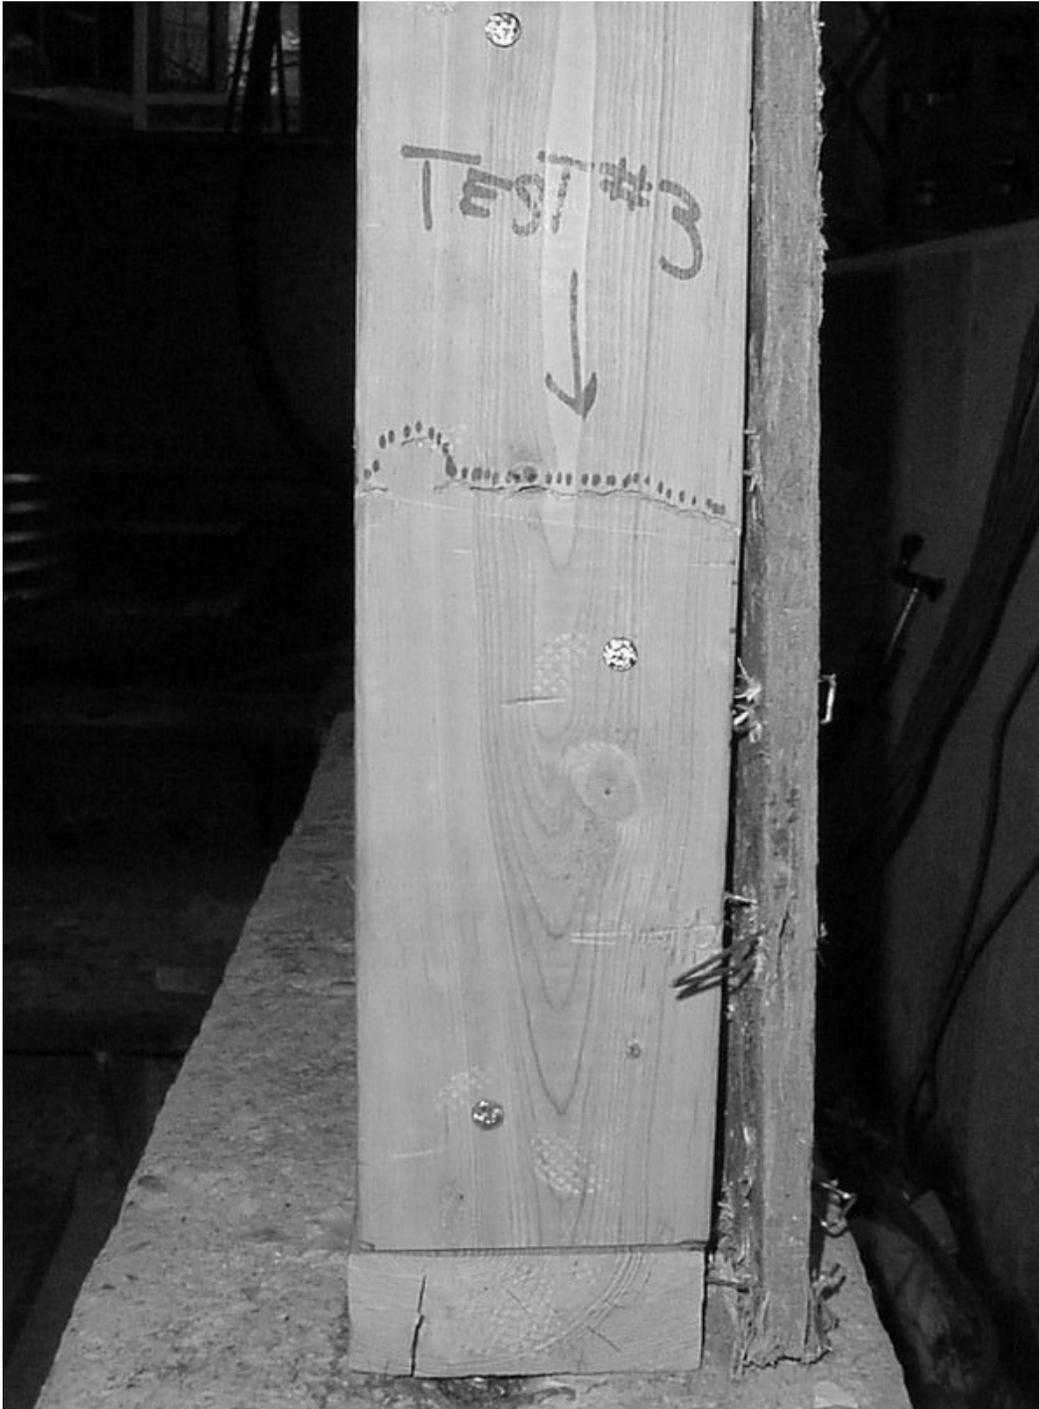
For panel, 3 SLS capacity was 4.8 kips at a displacement of 1.8". The SLS points in the positive and negative quadrants of the hysteresis loop occurred 11 cycles apart, which is closer together than panel 2, but farther apart than other tests. The failure of the panel began in the lower corners of the panel and spread inward towards the center of the panel. It is unclear at what cycles the end-wall studs fractured, as shown in Figure 5.3. The fasteners did pull out of the framing along the end-wall studs, and the sheathing's connection to the sill failed from the fasteners shredding the sheathing in the lower corners. Since the sill plate stayed intact, the sheathing failure spread upward along the end-wall studs despite having two rows of fasteners. The hysteresis loop for this panel, which is representative of the first test group, is shown in Figure 5.4.

Figure 5.3. Panel 3 sheathing tearing and end wall stud crack.

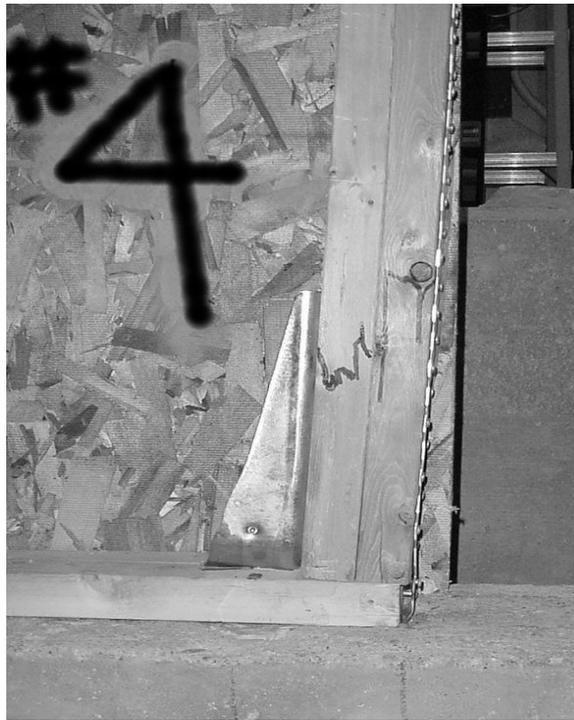
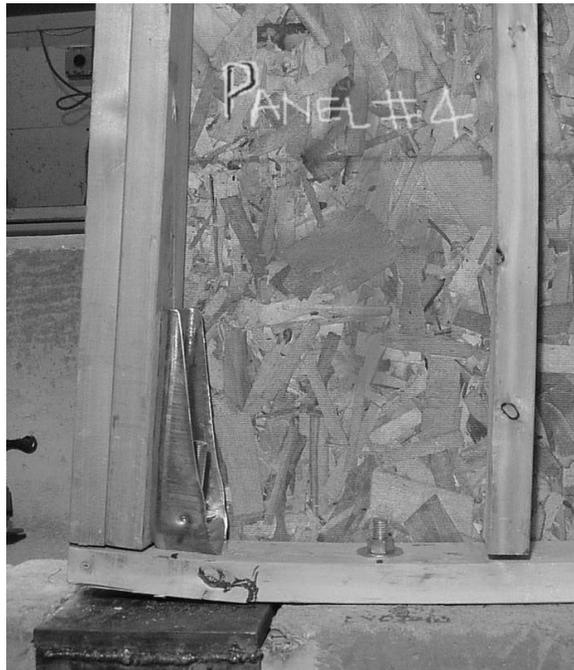
The strap caused the sill plate to flex along its length at the sill plate's ends during uplift, relieving stress on the staples. During compression on the panel's end-wall studs, crushing of the sill plate occurs and the stress on the bottom corner staples is increased. Figure 5.6 shows photos of the panels displaced at the end of the test cycle. Figure 5.6 also demonstrates the effects of the strap; note the sill plate curling upward. The failure mechanism for the test was the sill plate cracking, not splitting along its length, due to cross-grain tension and the sheathing pulling away from the studs as the staples worked out of the framing. This type of failure will absorb more energy, which can be seen on the hysteresis loop for this test in Figure 5.5. The backbone curve from the loop has a

Figure 5.6. Failure components panel 4.

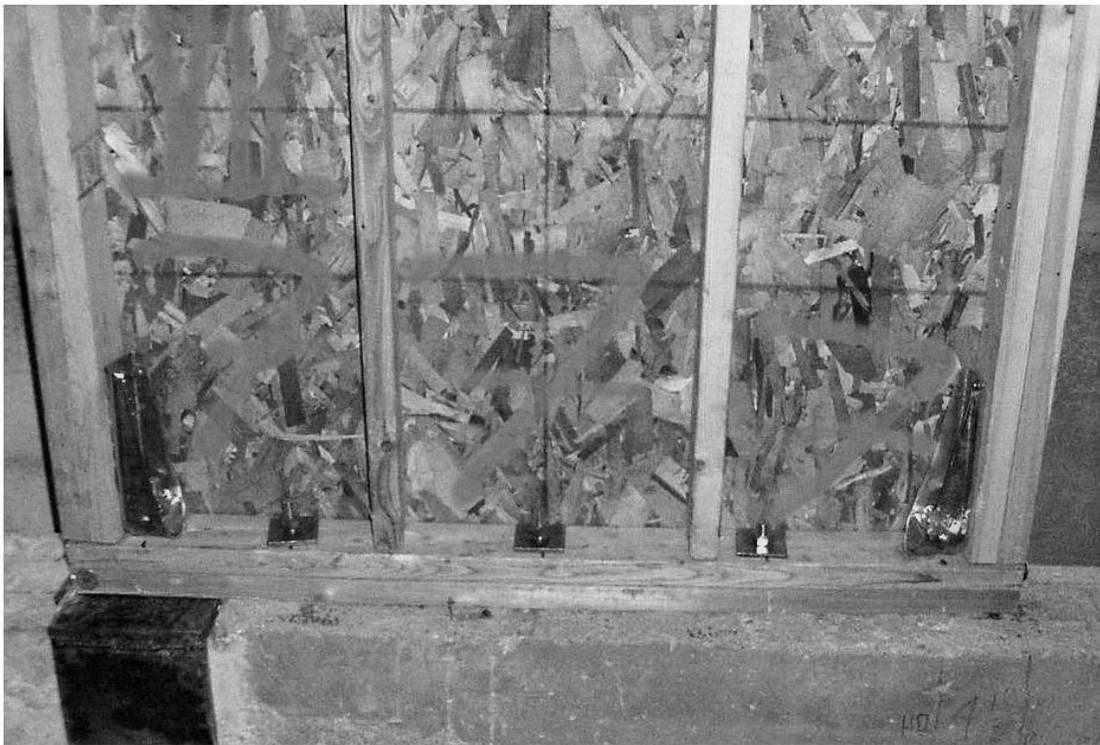
place against the concrete. Figure 5.8 shows the base configuration and Figure 5.9 shows a close up of the strap to threaded rod connection. Panel 7, with the new configuration, had better performance than the previous tests. The YLS capacity was 3.9 kips at a displacement of 0.95" after 17 cycles. The SLS capacity was 6 kips at a displacement of 2.4" occurring between cycles 52 and 56. These capacities represent a 30% increase in yield strength and a 60% increase in ultimate strength over the best performance of the standard construction panels used in tests 2, 3, and 5. The increase in ultimate strength and the broader back-bone curve demonstrated the modifications to the base of the shear

Figure 5.8. Base configuration of panel 7.

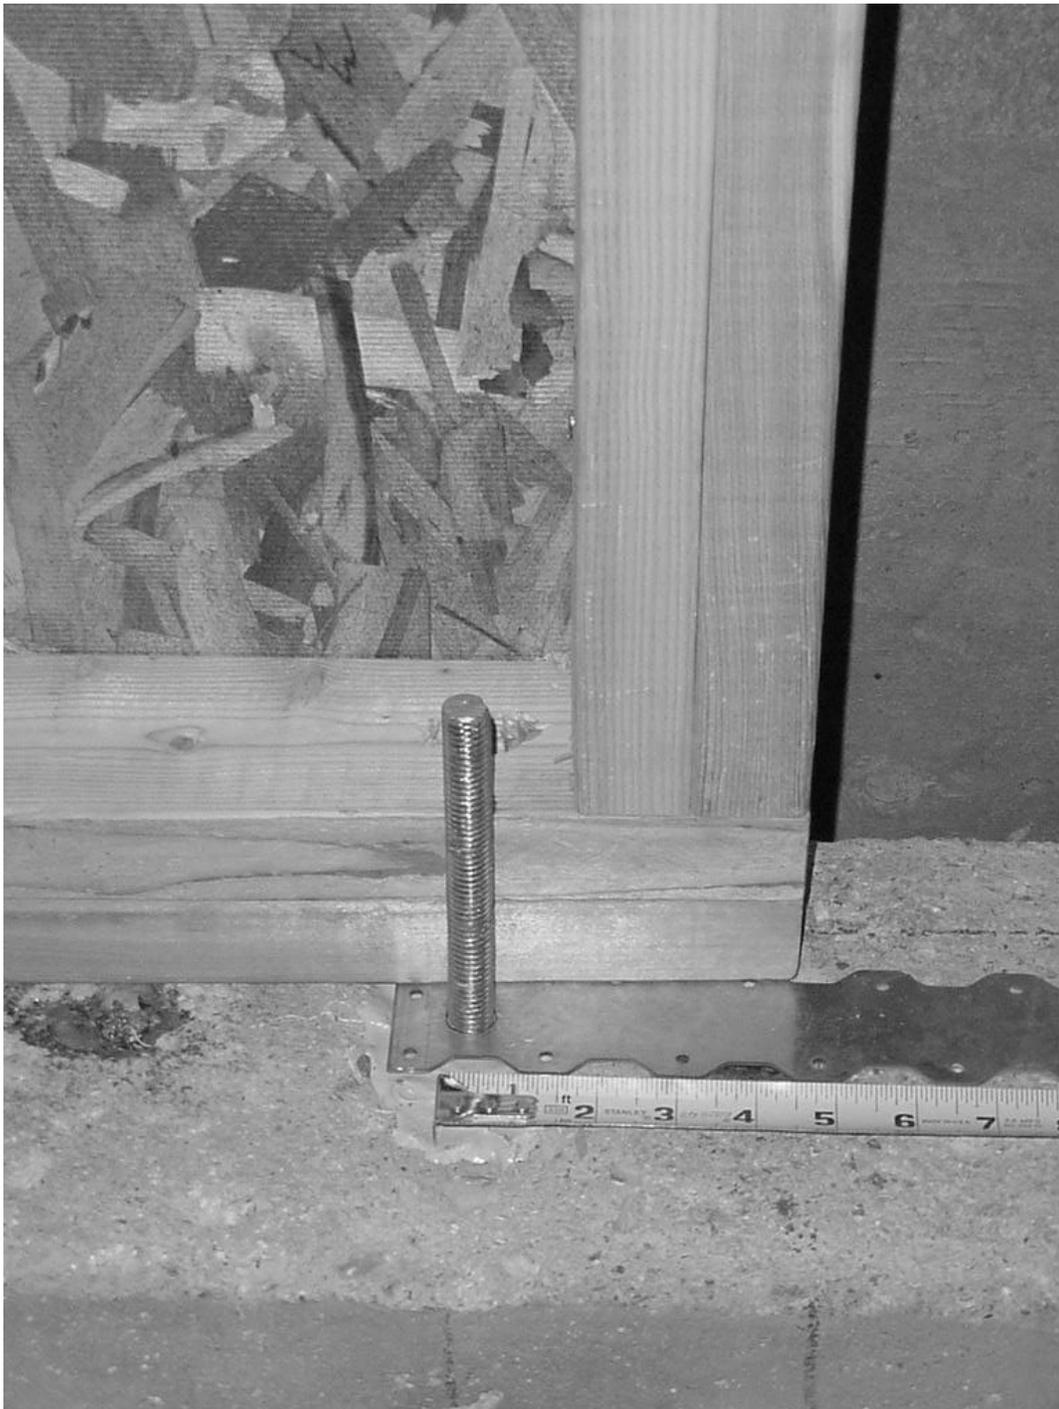
Figure 5.9. End-wall stud strap panel 7.

wall that prevented premature failure of the wall components. Failures occurred with the end studs splitting, the sill plate splitting, and the sill plate crushing where the ST strap held the end-wall studs down, with several components of the hold-down failing at a calculated uplift of 12 kips (see Figures 5.9, 5.10, and 5.11). The hold-down component failures included the screws bending and shearing off at the heads, the sill plate crushing under the toe of the hold-down, and the hold-down structure beginning to come apart. During the entire test, the sheathing fasteners showed little sign of failure. Some staples began to work their way out of the studs, but the wall sheathing remained fixed to the base of the shear wall. The failure mechanism of the panels shifted from failing at the sheathing where there were only single rows of fasteners to failing at the sill plate, end-wall studs, and hold-down components. By improving the fixture of the base of the shear wall, the panel strength and ductility of the element was improved. Figure 5.12 shows the hysteresis loop for this panel.

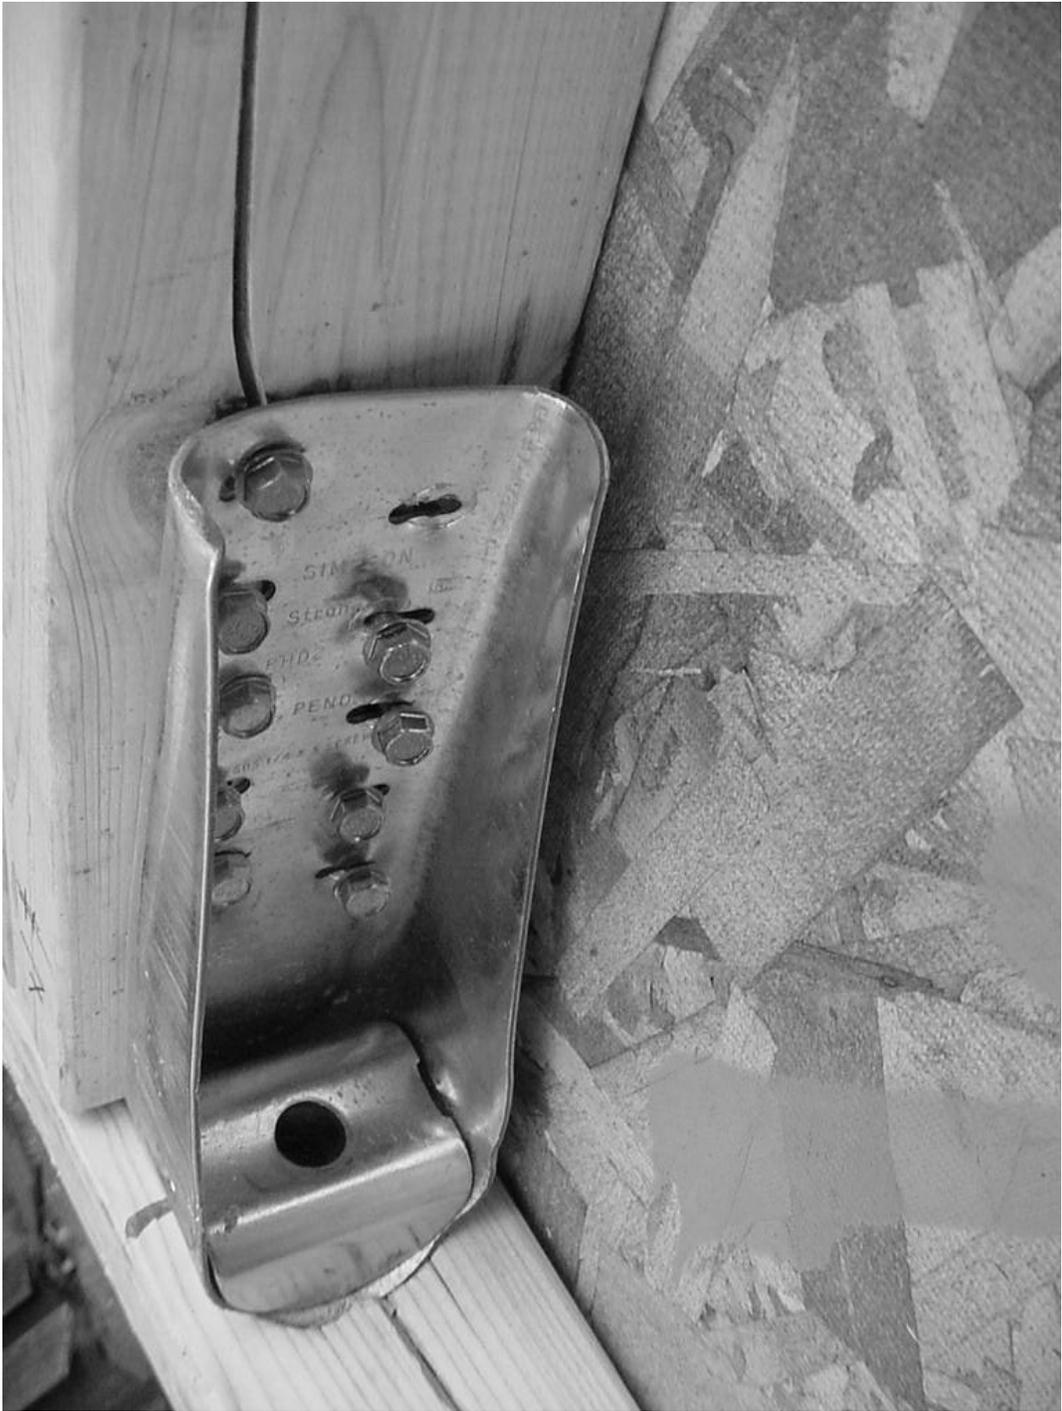
Figure 5.10. End-wall stud, hold-down, and sill failure panel 7.
